Fracture and structural modifications induced by cathodic hydrogenation after nitriding on AISI 304

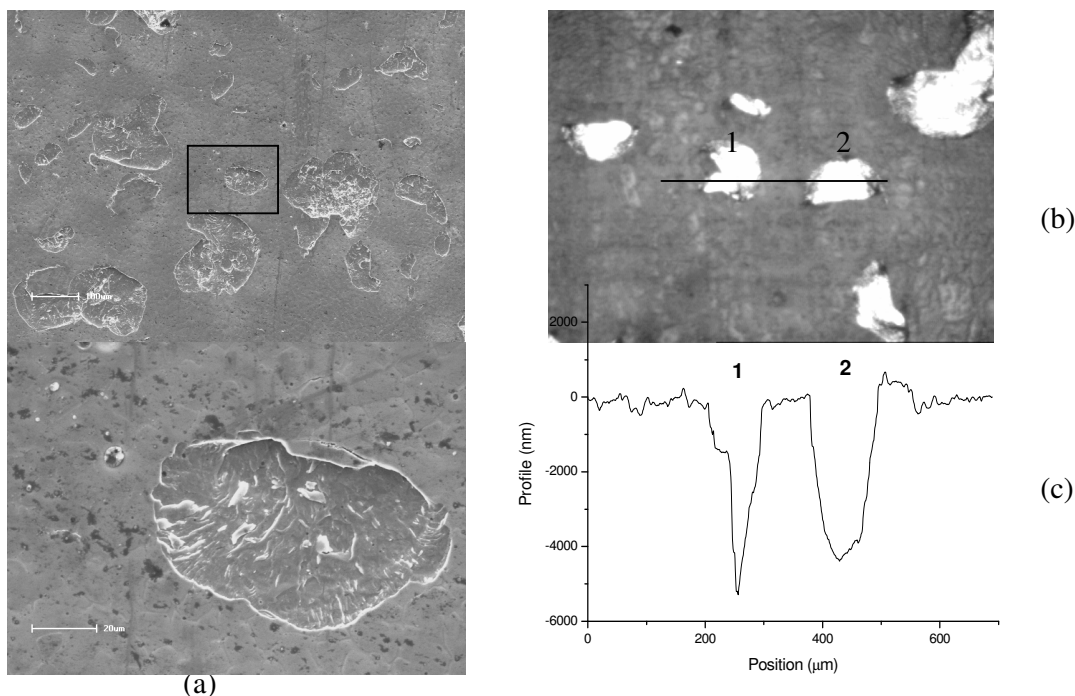
Abstract – Hydrogen embrittlement in steels is a well known process. In this work we investigate hydrogen evolution in the AISI 304 steel samples that were nitrided by glow discharge. After nitriding samples were submitted to cathodic hydrogenation. Untreated and nitrided samples show very different fracture patterns after hydrogenation. The fractures of nitrided samples are mostly of chipping type, while the not nitrided samples show fractures that are normal to the surface.

Figure 1 – (a) SEM of chipping fractures on AISI 304 steel nitrided at 550 °C and hydrogenated. (b) Image of region where the profile was made. (c) Profile indicating the depth of chipping due to hydrogen accumulation under the nitrided layer.
